# Effects of Contamination and Cleaning on Parachute Structural Textile Elements

Catherine Mollmann<sup>1</sup>

*Airborne Systems North American, Pennsauken, NJ, 08109*

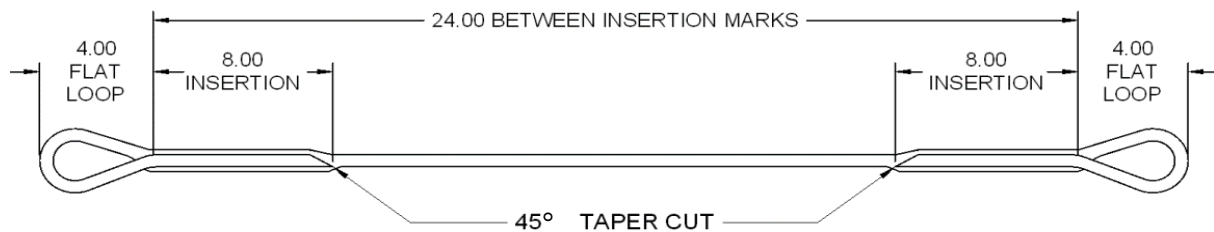
**Figure 1. Standard Cord Sample Configuration**

Further construction details of the Kevlar and Vectran cord samples are shown in Figure 1:

Material	Sample Cut Length	Other Notes
Kevlar® Cord	56"	4.00" flat loop with 8.00" insertions (see Figure 1)
Kevlar® Webbing	64"	--
Nylon Broadcloth	36"	Unraveled to 1.50" or 2.00" width per ASTM D 5035-06
Nylon Webbing	64"	--
Vectran® Cord	56"	4.00" flat loop with 8.00" insertions (see Figure 1)

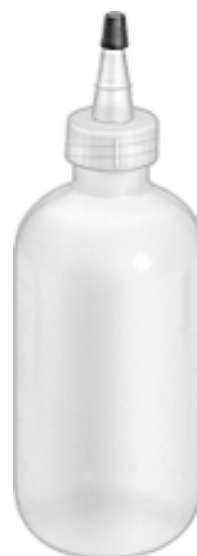
**Figure 2. Plastic Squeeze Bottle**

During the application of the contaminants and cleaning agents, different containers and methods were used to store and apply them to the materials. For sewing machine oil, stamping ink, Sergene, EverBlum, ink thinner, and isopropyl alcohol, a standard 16 oz plastic squeeze bottle with a standard nozzle (McMaster-Carr P/N 4176T6) was used. See Figure 2. This bottle was used to evenly apply contaminants and cleaning agents to the samples. Dirt, taken from Yuma Proving Grounds in Yuma, Arizona, was stored in a plastic bag and applied by hand. Basting glue was applied to the samples using a hot-glue gun.

10 samples of each material were contaminated with a line of Sergene (see Figure 14) using the plastic squeeze bottle shown in Figure 2. After applying Sergene to a sample, a lint-free rag was used to soak up as much Sergene as possible (see Figure 15). This was done for 5 samples per material type. After removing as much Sergene as possible, the samples were allowed to dry.

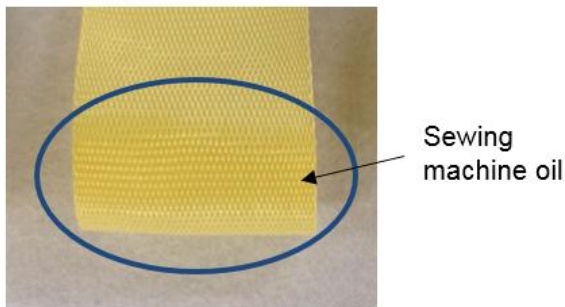
**Figure 3. Kevlar® Webbing Contaminated with Sewing Machine Oil**

For each material type, 10 samples were contaminated with a line of sewing machine oil (see Figure 3). Approximately the same amount of sewing machine oil was applied to each sample using the plastic squeeze bottle shown in Figure 2. Figure 3 below shows Kevlar® webbing contaminated with sewing machine oil. When the sewing machine oil dried, EverBlum was used to remove the contaminant on 5 of the 10 samples (see Figure 4).

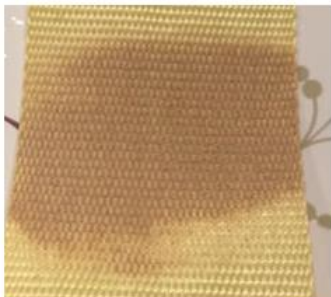
**Figure 8. Kevlar® Webbing Contaminated with Dirt**

For each material type, 20 samples were contaminated with dirt (see Figure 8). Approximately the same amount of dirt was manually applied to each sample to thoroughly rub in the dirt. Woolite® was used to remove the dirt from 5 samples of each material type (see Figure 9). Woolite® was applied to the materials using a spray can and the material was lightly scrubbed with a wet sponge. Dove® soap and warm water were used to remove the dirt from 5

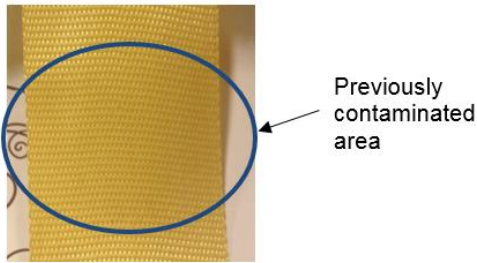
**Figure 10. Kevlar® Webbing Contaminated with Dirt and Cleaned with Dove®**

more samples (see Figure 10). The Dove® soap was mixed with warm water and a lint-free rag was used to apply the cleaning agent to the materials. Castile soap and warm water was used to remove the dirt from 5 samples of each material type (see Figure 11). The Castile soap was mixed with warm water and a lint-free rag was used to apply the cleaning agent to the materials.

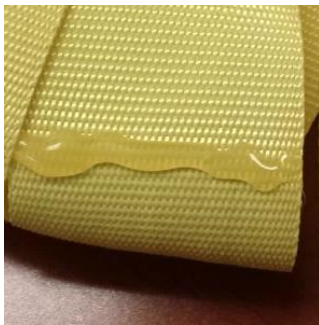
**Figure 12. Kevlar® Webbing Contaminated with Basting Glue**

For each material, 10 samples were contaminated with a line of basting glue (see Figure 12) using a hot glue gun. After the basting glue dried, the sample was cleaned with isopropyl alcohol. A small amount of isopropyl alcohol was initially applied to the material; after sitting for about a minute, the line of basting glue was carefully peeled off. A lint-free rag, saturated with isopropyl alcohol, was then used to remove the remainder of the basting glue. Care was taken to avoid damaging fibers during cleaning. See Figure 13.

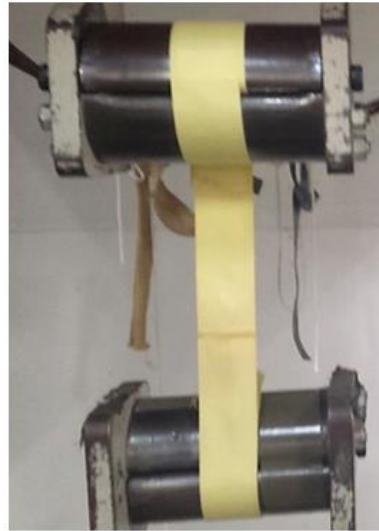
Figure 17. Kevlar® Webbing Sample Ready to Test

Figure 17 shows an example of a Kevlar® webbing sample installed in the fixture and ready to be tested. Care was taken to ensure that the sample was positioned in the middle of the grips. Once the test was started, the bottom grip moved downward at 3 in/min until the sample broke. This loads up the webbing and forces the Sedam grips to engage the material.

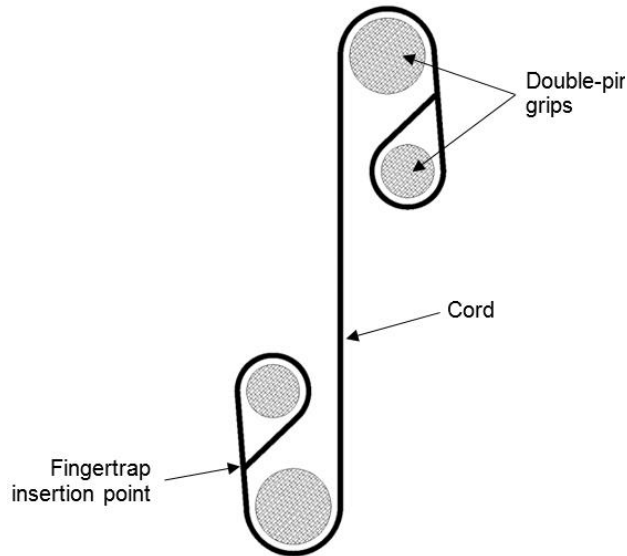
**Figure 18. Cord Routing**

Both Kevlar® and Vectran® cord samples were tested on the 30k Tinius Olsen using the double-pin grips. Figure 18 below is a front view of the test setup, showing how the cord routed along the pins. The black lines represent the path of the cord and the shaded portions show the position of the double-pin grips. Care was taken to ensure that the cord was not twisted over its length.

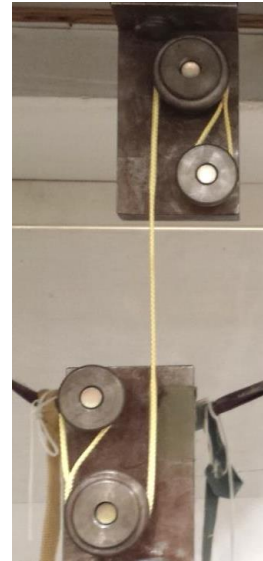
**Figure 19. Kevlar® Cord Sample Ready to Test**

Figure 19 shows an example of a Kevlar® cord sample installed in the fixture and ready to be tested. Once the test was started, the bottom double-pin moved downward at 3 in/min.

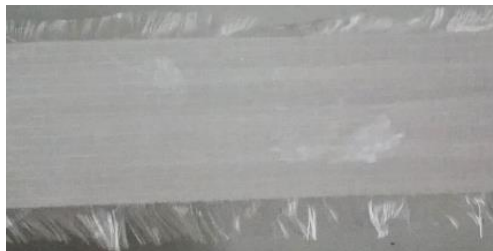
Figure 24. Example 1 of Cleaned Sample

4 of the 8 rust-contaminated samples were then cleaned. Based on anecdotal and internet research, a solution of commercially-available lemon juice and table salt was mixed to a "slushy" consistency and applied to the rusted sections. The samples were then placed outside under direct sunlight for several hours. This process produced samples with little to no trace of rust when the solution was washed off with water. See Figure 24 and Figure 25:

Only Nylon broadcloth was tested with respect to rust contamination. The sections of broadcloth with rust on them, when compared with uncontaminated areas, experienced no degradation in strength. While the cleaning process of lemon juice, salt, and direct sunlight completely eliminated the appearance of any rust, the strength was degraded by approximately 25%. Also, sunlight is known to be damaging to Kevlar®, which may be near the Nylon broadcloth on an actual parachute. Therefore, it is recommended to not clean the rusted areas on Nylon broadcloth. If a clean appearance is still sought, it is recommended to replace the sections or panels entirely.
